Subject: May 13, 2014 CWA Compliance Evaluation Inspection

**CWA COMPLIANCE EVALUATION INSPECTION REPORT
U.S. ENVIRONMENTAL PROTECTION AGENCY, REGION 5**

Facility: Imperial Marble Corporation
327 East LaSalle Street
Somonauk, Illinois 60552
41.630716, -88.678245

Date of Inspection: 5/13/2014 – 5/14/2014

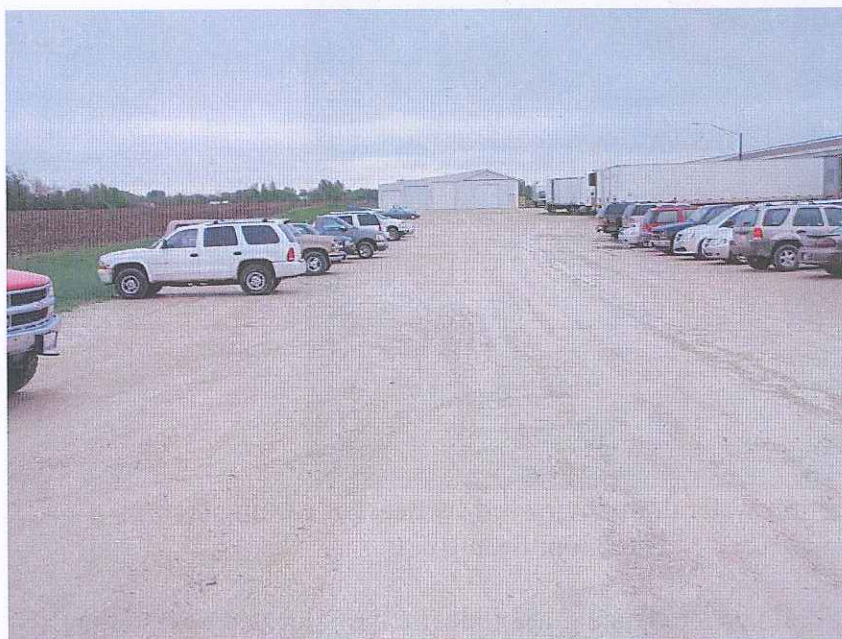
I observed the parking area on the east side of the facility (Photo P1010245) as well as the resin unloading area (Photo 1010241). The very north end of the driveway and parking area appeared to drain to the north to the roadside ditch while the remainder of the Facility's storm water flowed to the Facility's storm water collection drains.

P1010245 Description: Parking area east of main plant. Out building in distance.
Location: North end of parking area. Direction: Facing south.

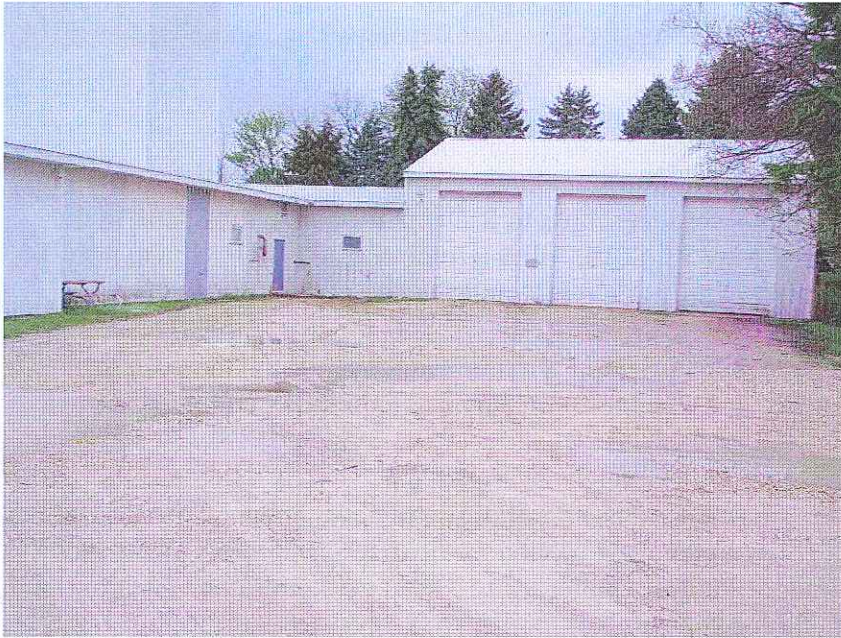
P1010241 Description: Resin unloading area on the north end of the main plant.
Location: North end of property. Direction: Facing west.

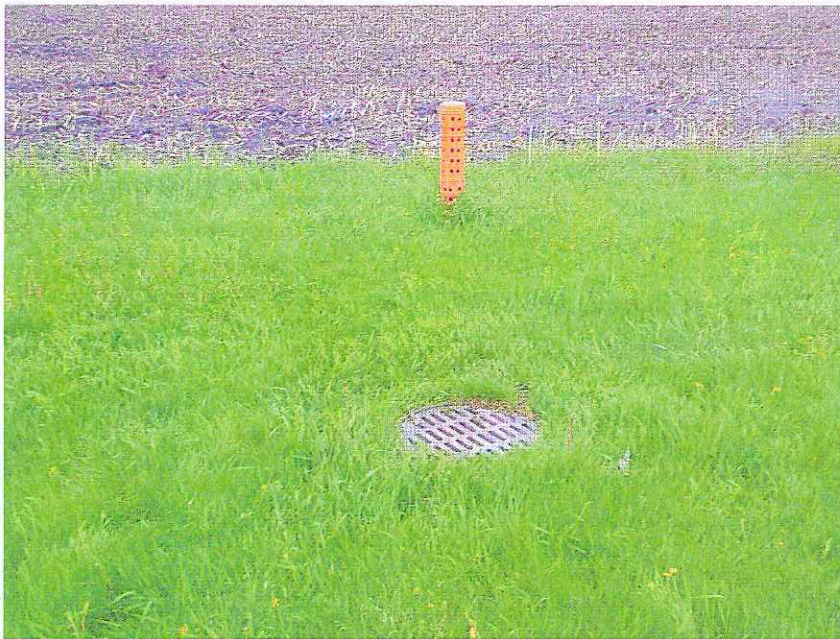
I observed a storm water drain and tile riser for the adjacent field located to the east of the parking area in the grassed area (photo P1010247).

P1010247 Description: Storm water drain in grassed area east of parking area.
Location: East of parking area. Direction: Facing east.

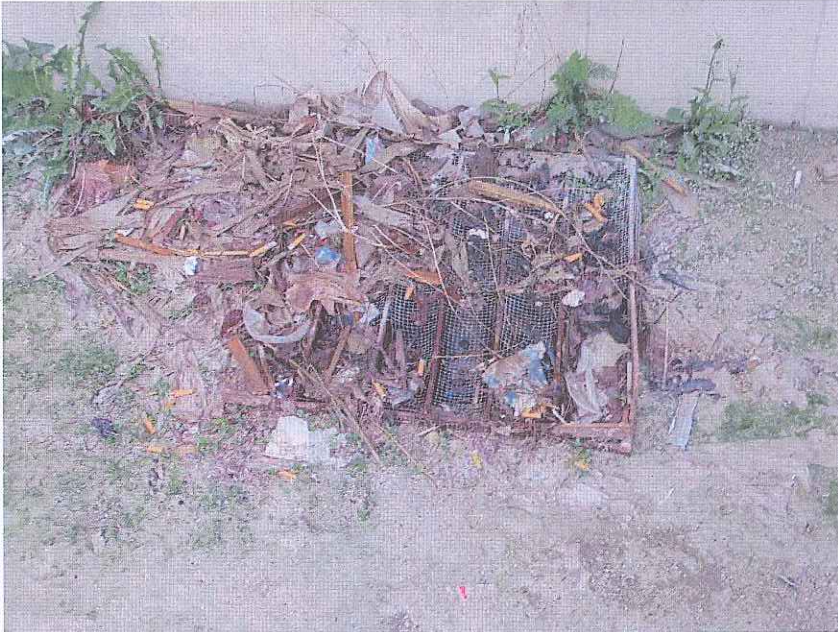
I observed a storm water drain covered by a grate and wire mesh located next to the loading dock on the east side of the main plant (photos P1010249 and P1010250).

P1010249 Description: Storm water drain in east side loading dock.
 Location: Loading dock on east side of main plant. Direction: Facing down.
 Date: 5/13/2014

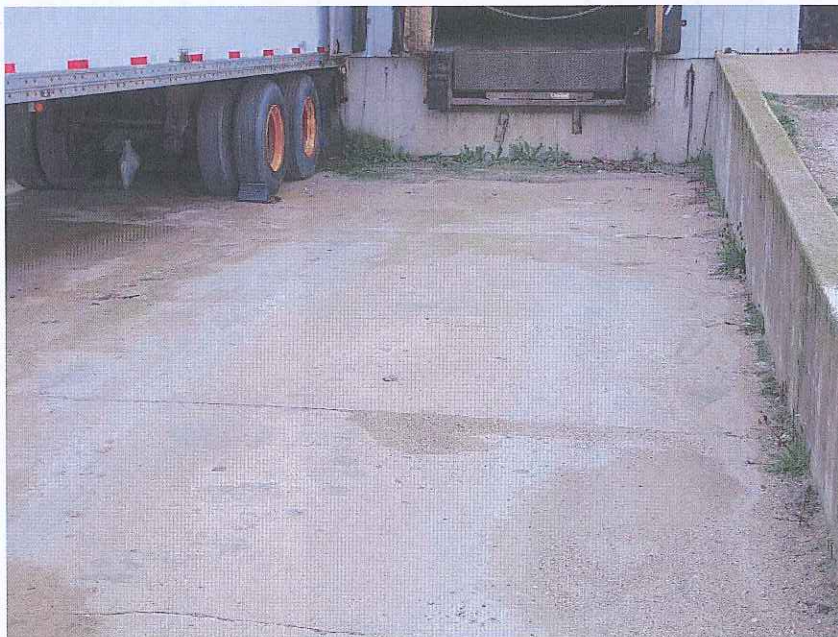
P1010250 Description: Storm water drain in east side loading dock.
 Location: Loading dock on east side of main plant. Direction: Facing west.
 Date: 5/13/2014

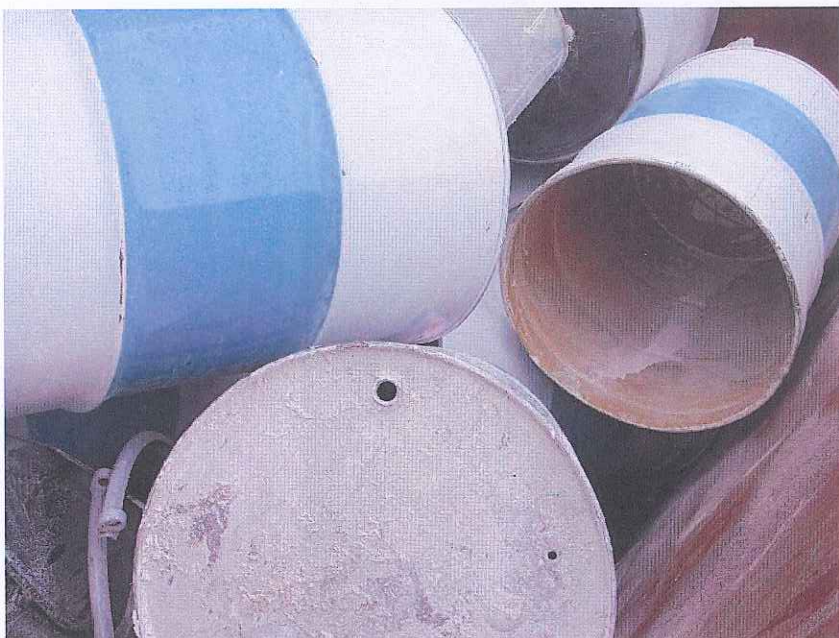
I observed an outdoor storage area on the south side of the main plant (Photo P1010257). I observed a white residue on the ground around the outdoor storage area. This area drained to the south. There was a roll-off dumpster filled with used barrels located south of the main plant and west of the out building (Photo P1010264). I observed that the bottom of the dumpster was rusted through and that there was the potential for precipitation to come in contact with the contents of the dumpster and then flow to the storm drain located in the grassed area south of the main plant (photos P1010265, P10267, P1010260, P1010258).

P1010267 Description: Roll off dumpster with empty barrels.
Location: West of out building. Direction: Northwest.

- 4) A source of potential storm water contamination observed during the inspection was from non-covered dumpsters. The SWPPP states that "Covers or tarps for the dumpsters will be investigated and options for enclosure will be evaluated." There was no evidence that this investigation was completed.

On January 22, 2016, I spoke with Mr. Chad Cartwright, Plant Manager. Mr. Cartwright informed me that since the inspection IMC has resumed all monthly, quarterly, and annual inspection. Mr. Cartwright sent me that last three months of inspection reports. Mr. Cartwright also stated that for the sampling requirement of the quarterly observations of event discharges, IMC has sampled at the outfall of the storm water collection system. Mr. Cartwright provided copies of the last three quarterly sampling. Additionally Mr. Cartwright informed me that they had added SWPPP training to the employee's annual training. Mr. Cartwright stated that IMC has moved as much of the equipment that was stored in the outdoor storage area to indoor storage areas or under cover as possible. He also stated that IMC has put covers over all dumpster.

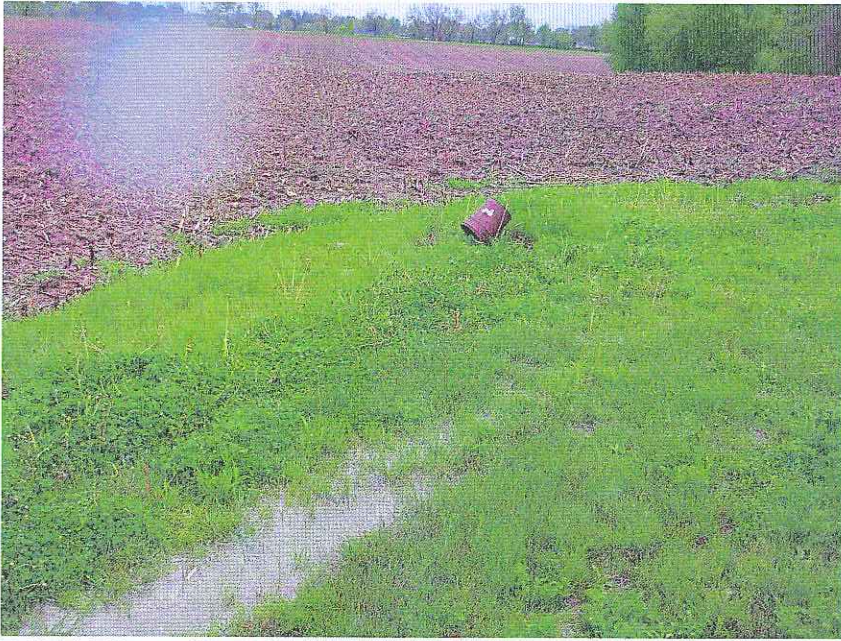
P1010260 Description: Storm water drain south of main plant.
 Location: South of main plant. Direction: Facing south. Date: 5/13/2014

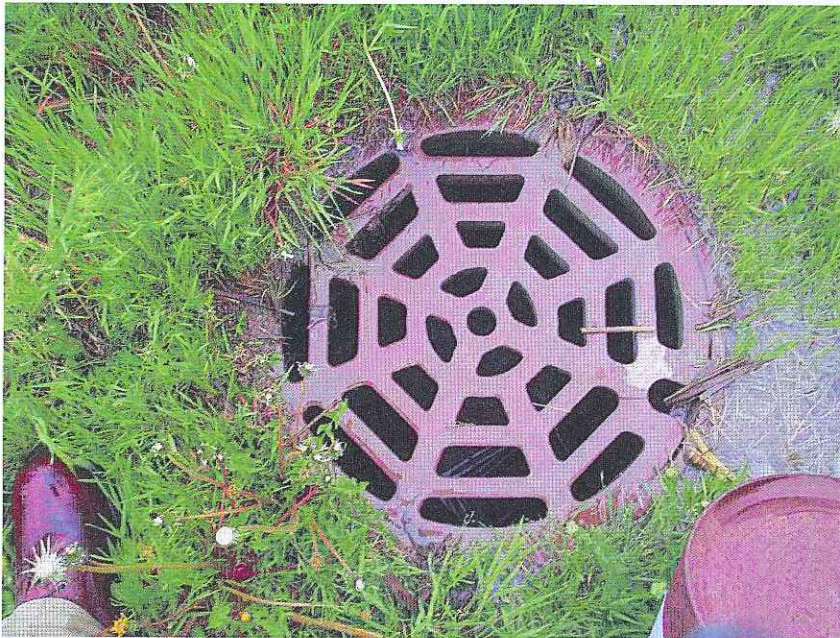
P1010258 Description: Storm water drain south of main plant.
 Location: South of main plant. Direction: Facing down. Date: 5/13/2014

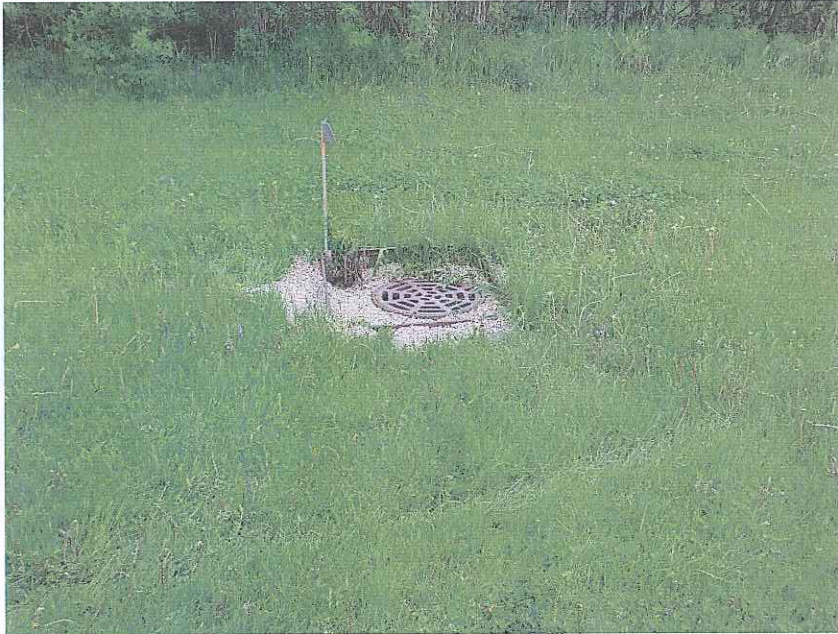
I observed a storm water drain located in the grassed area southeast of the main plant (photo 1010280). This storm water drain appeared to collect the storm water from the swale on the west side of the facility (photo P1010282).

P1010280 Description: Storm water drain with gravel surrounding it.
 Location: Southwest side of main plant in grassed swale. Direction: West
 Date: 5/13/2014

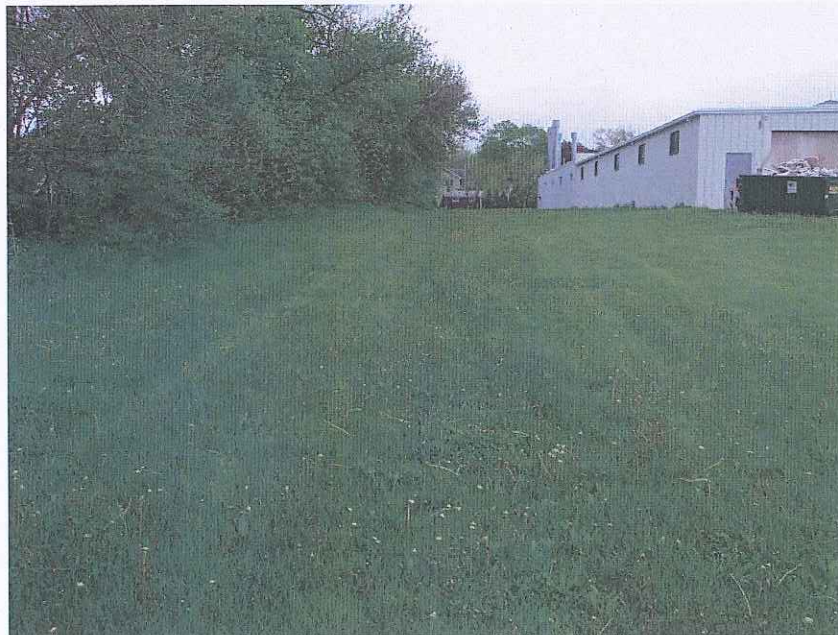
P1010282 Description: Grassed storm water swale on west side of main plant.
 Location: Southwest of main plant. Direction: North. Date: 5/13/2014

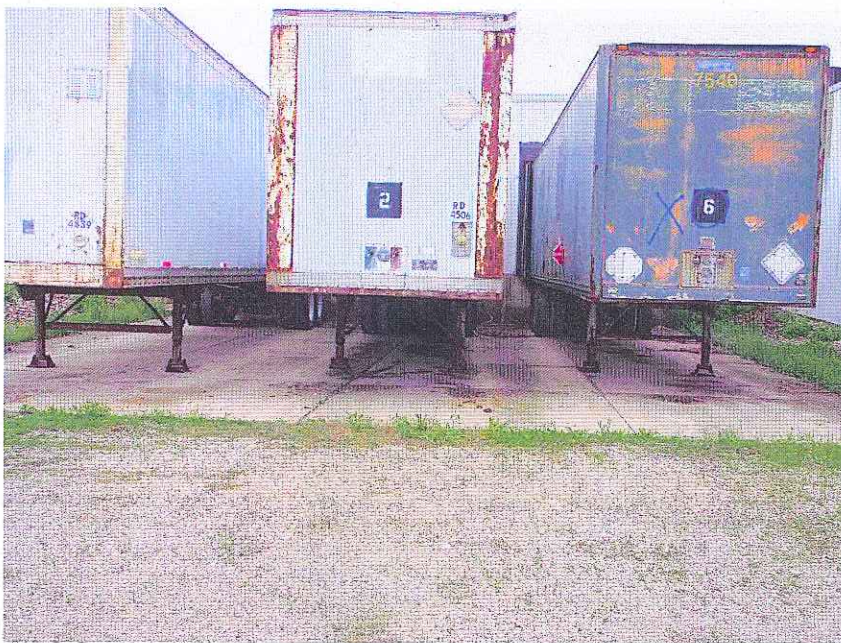
I observed a storm water drain located in the loading dock on the west side of the facility (photo P1010291, P1010286).

P1010291 Description: West side loading dock.
Location: West side loading dock. Direction: Down. Date: 5/13/2014

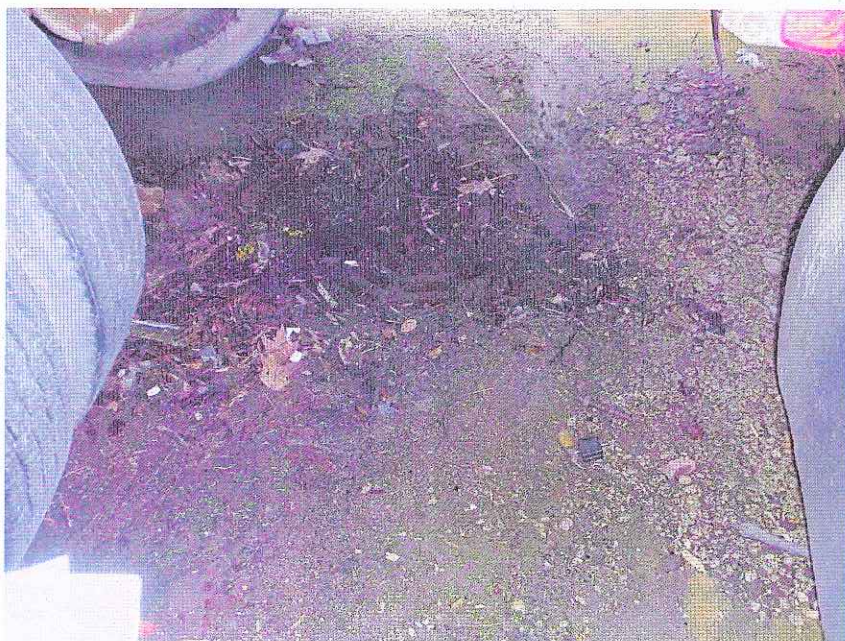
Description: Storm water drain in west side loading dock.
Location: West side loading dock. Direction: Down. Date: 5/13/2014

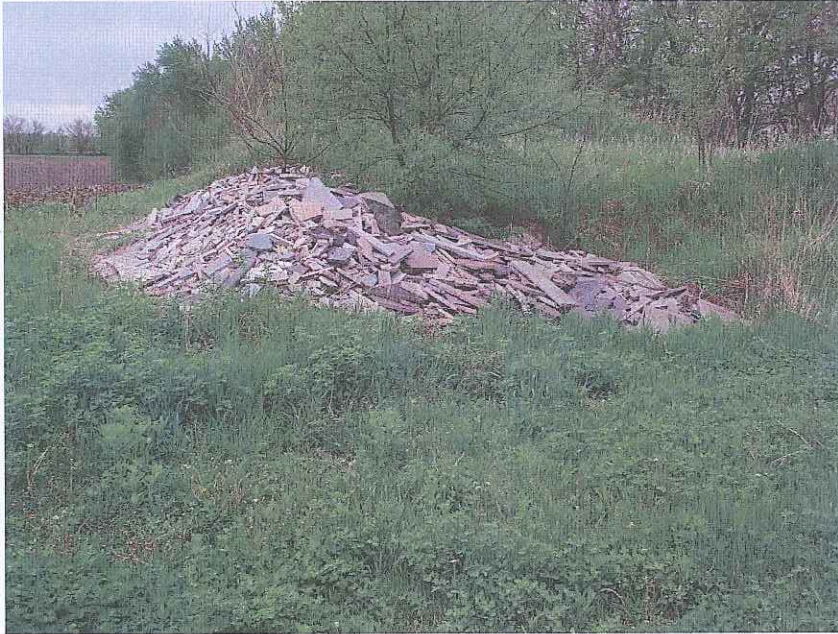
I observed a pile of waste stone from the time when IMC also cut natural stone bath surfaces (photo P1010292).

P1010292 Description: Pile of discarded natural stone from time when IMC manufactured cut stone bath surfaces. Location: Southwest of main plant.
Direction: South. Date: 5/13/2014

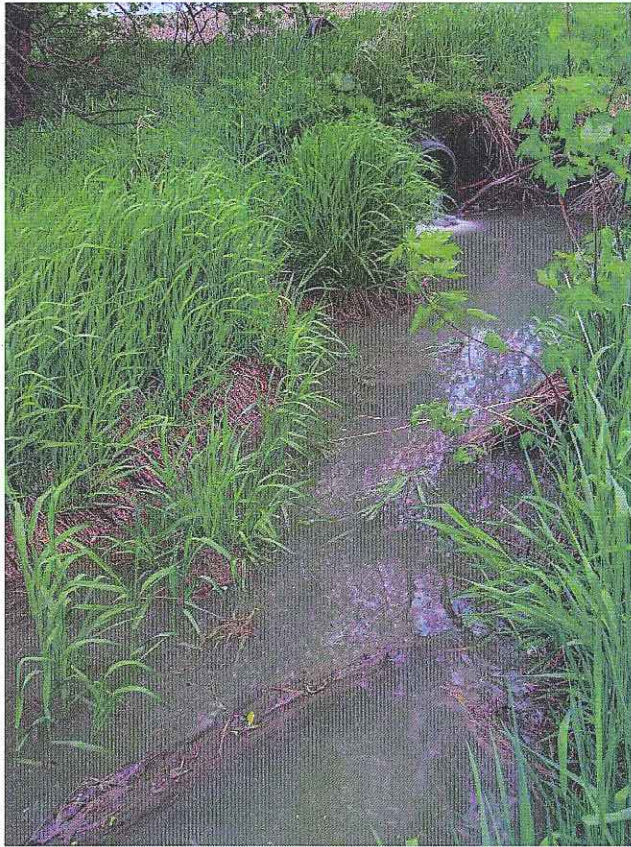
I walked to the outlet of the storm water drains located at the storm water retention pond south of the facility (Photo P1010294, P1010295, and P1010296). I observed an off-white foam on the surface of the water immediately at the outlet (Photo P1010297).

P1010295 Description: Outfall of storm water collection system. Location: East side of storm water retention pond. Direction: Northeast. Date: 5/13/2014

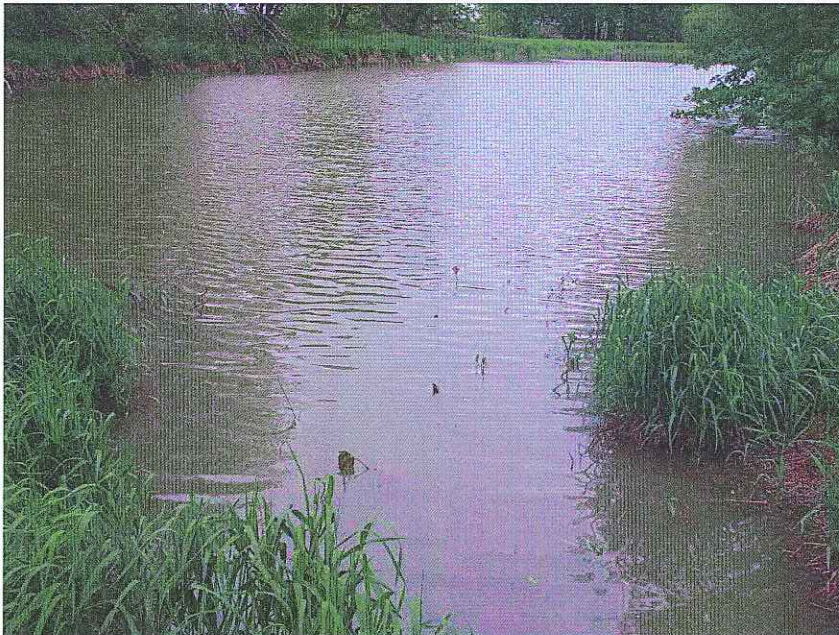
P1010296 Description: Storm water retention pond. Location: East end of storm water retention pond. Direction: West. Date: 5/13/2014

I walked around the storm water retention pond and found that the pond appeared to be located at the low point of a bowl feature with no outlet to surface waters.

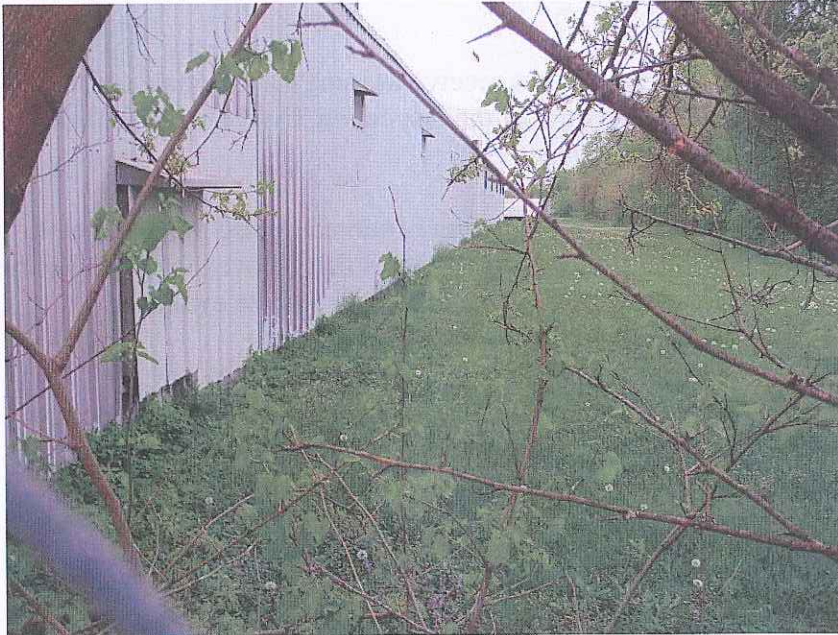
On the second day of the inspection, 5/14/2014, I walked on the west side of the main plant from north to south. I observed the grassed storm water swale located west of the main plant (photo P1010303).

P1010303 Description: Grass swale on west side of main plant.
Location: Northwest side of main plant. Direction: South. Date: 5/14/2014

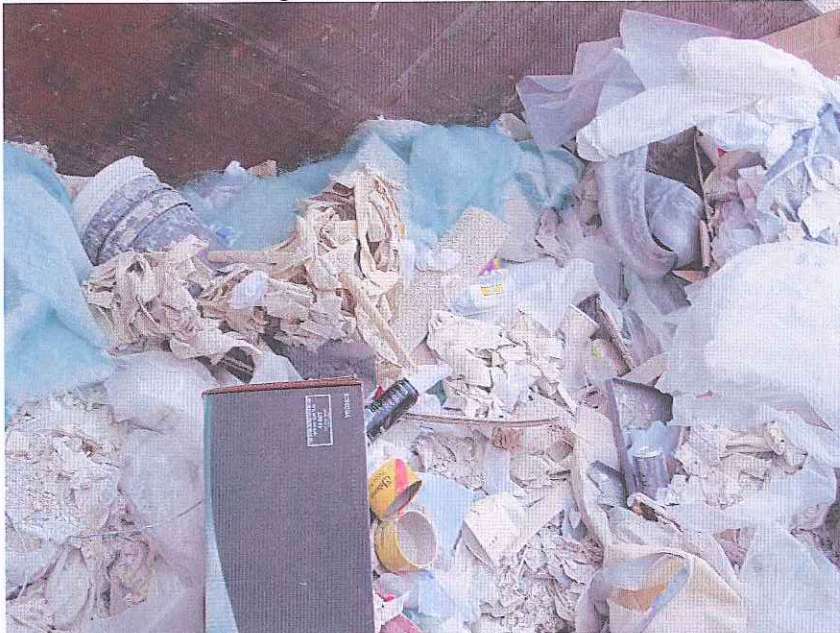
14: P1010253 Description: Contents of open topped dumpster east of main plant.
Location: East of main plant. Direction: NA Date: 5/13/2014

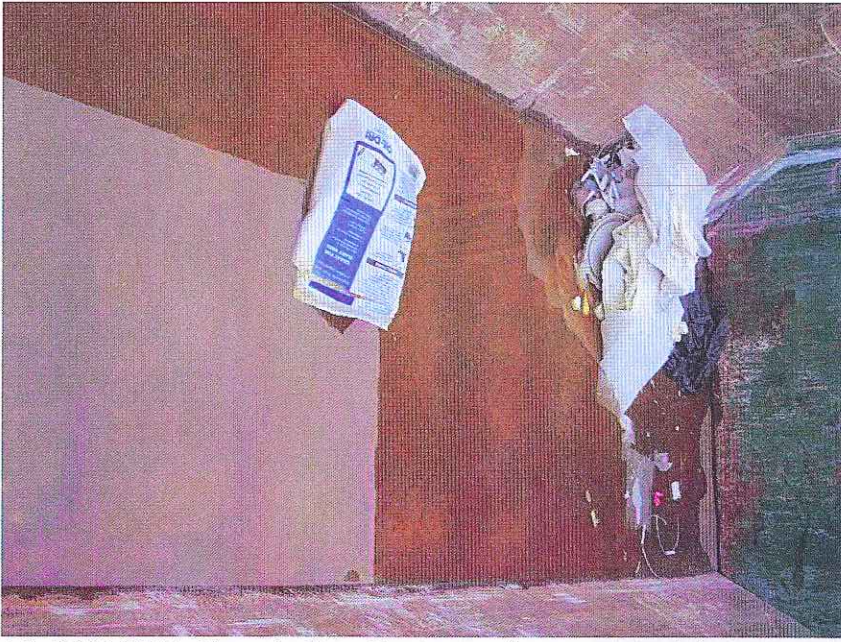
15: P1010254 Description: Contents of open topped dumpster east of main plant.
Location: East of main plant. Direction: NA Date: 5/13/2014

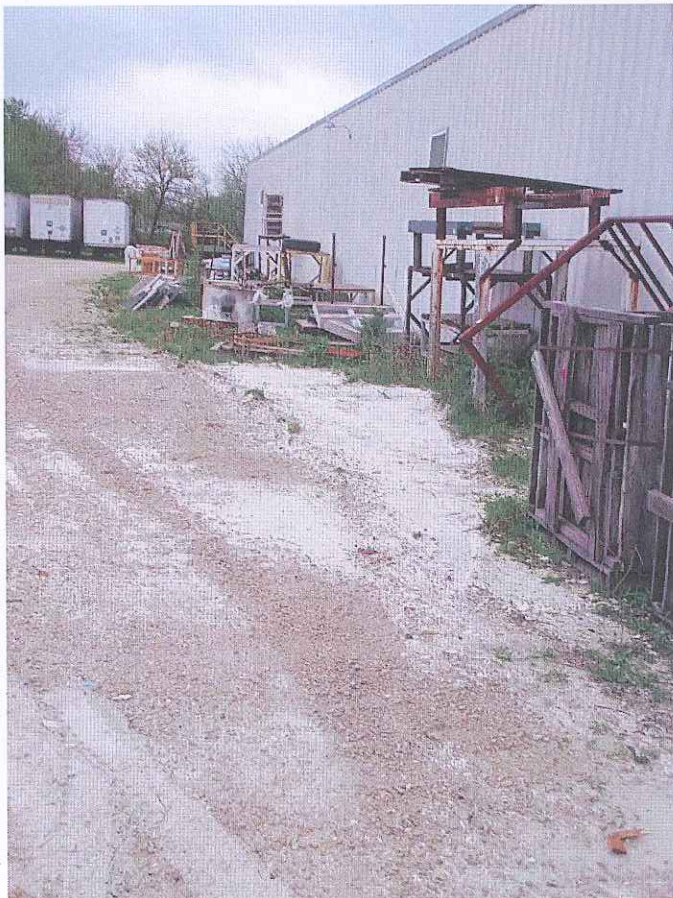
- 5) A source of potential storm water contamination observed during the inspection was the outdoor storage area. The SWPPP states that "Whenever possible, any scrap steel, metal drums, and miscellaneous metal parts will be stored under structures to prevent extended contact with storm water runoff."

18: P1010257 Description: Outdoor storage area on south end of main plant.
 Location: Southeast corner of main plant. Direction: Facing west. Date: 5/13/2014

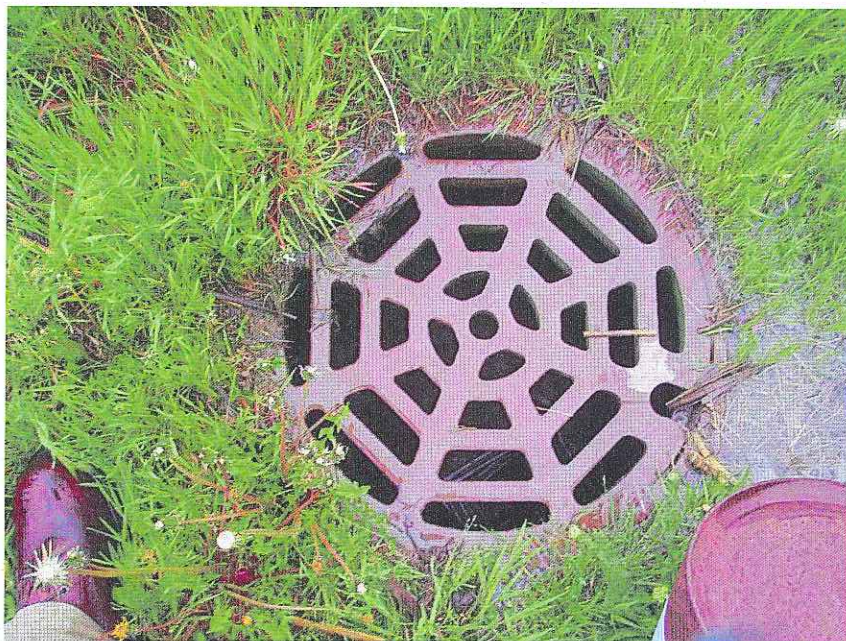
19: P1010258 Description: Storm water drain south of main plant.
Location: South of main plant. Direction: Facing down. Date: 5/13/2014

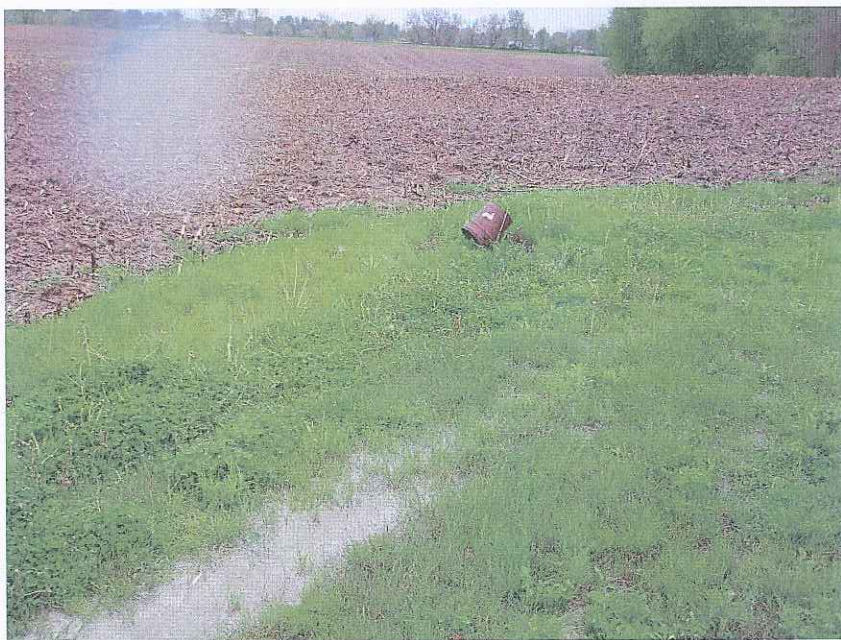
21: P1010260 Description: Storm water drain south of main plant.
Location: South of main plant. Direction: Facing south.

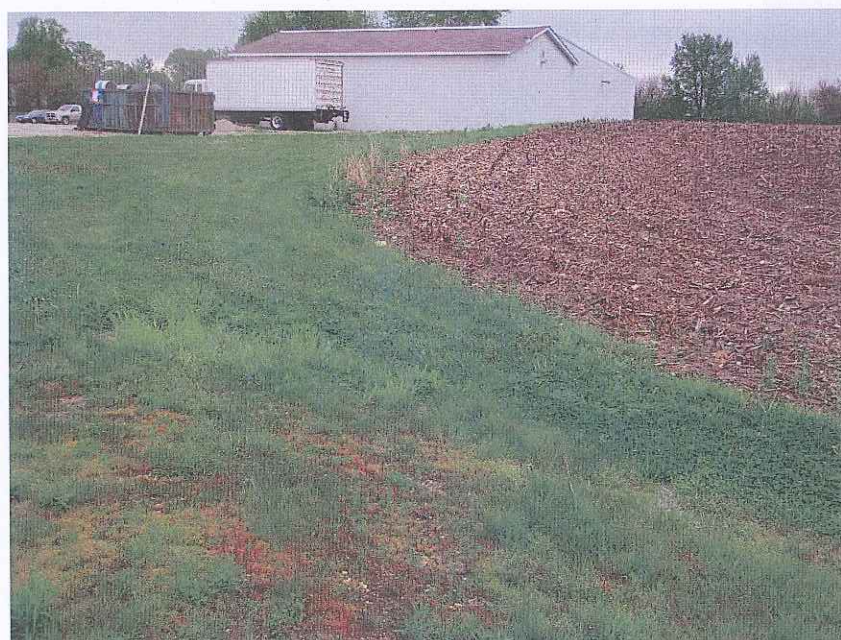
22: P1010261 Description: View from storm water drain south of main plant. Roll off dumpster with open barrels and out building in distance.

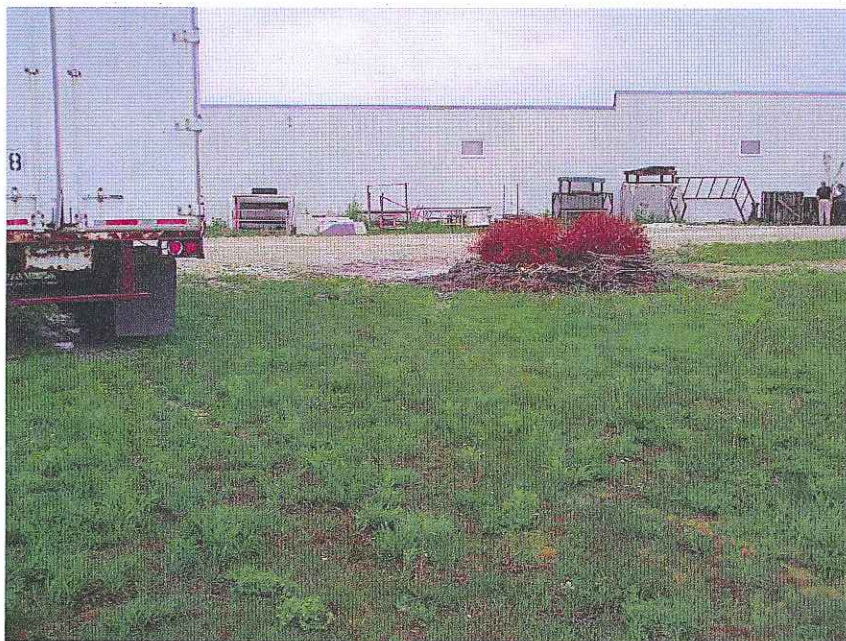
23: P1010262 Description: Exterior storage area on south side of main plant.

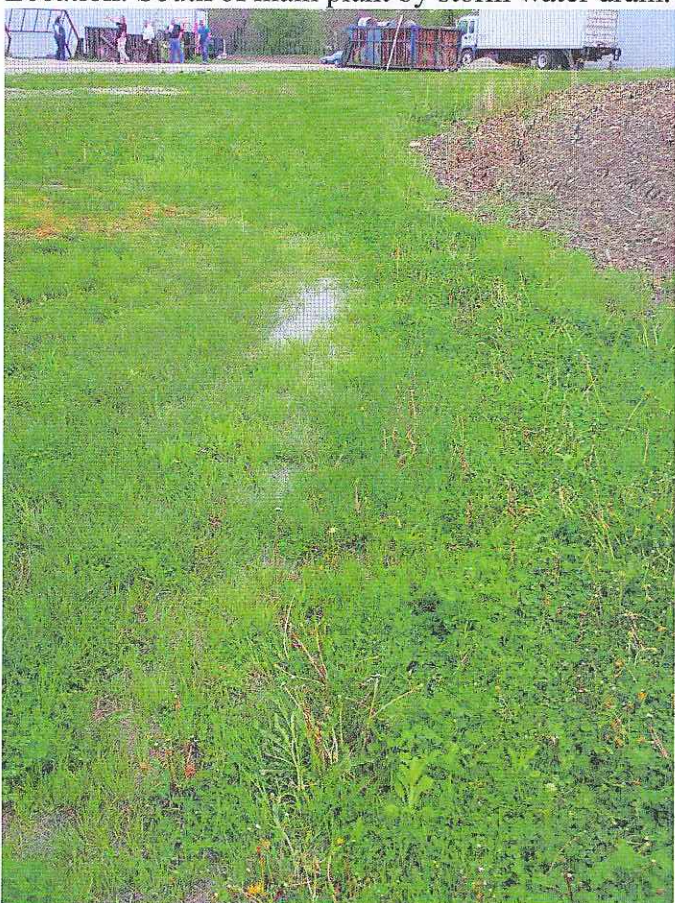
24: P1010263 Description: View from storm water drain south of main plant. Roll off dumpster with open barrels and out building in distance.

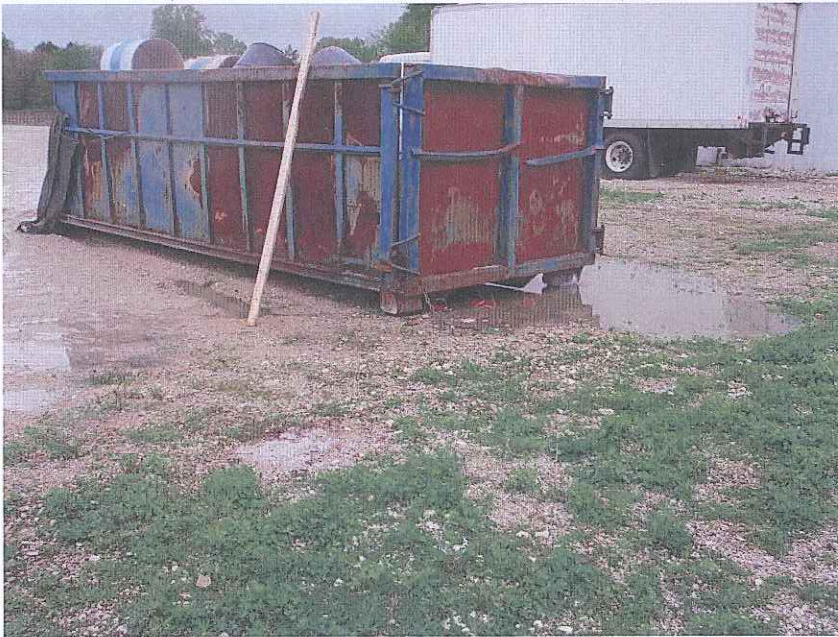
25: P1010264 Description: Roll off dumpster with empty barrels.
Location: West of out building. Direction: Northwest.

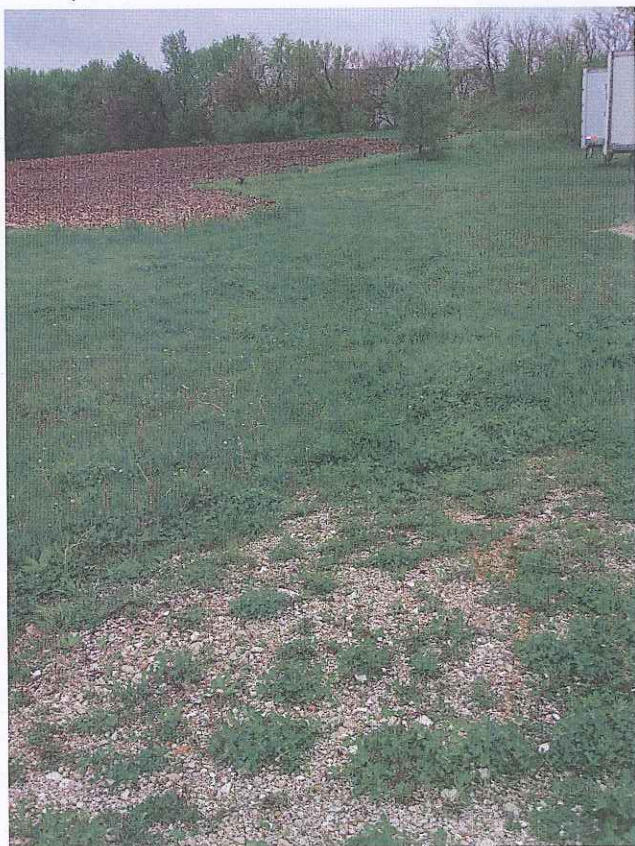
30: P1010269 Description: View from roll off dumpster towards south storm water drain.
 Location: West of out building. Direction: Southwest. Date: 5/13/2014

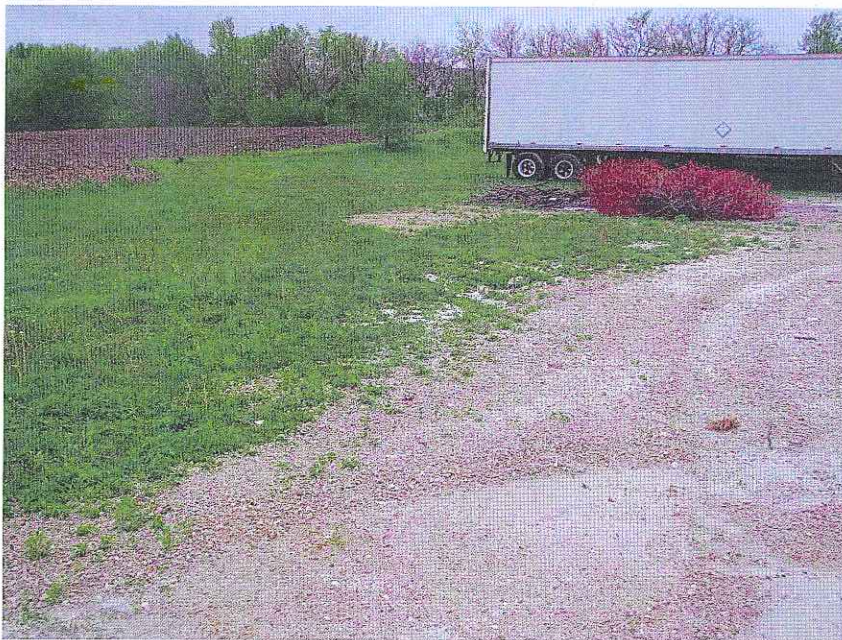
32: P1010271 Description: View from roll off dumpster towards south storm water drain.
Location: West of out building. Direction: Southwest. Date: 5/13/2014

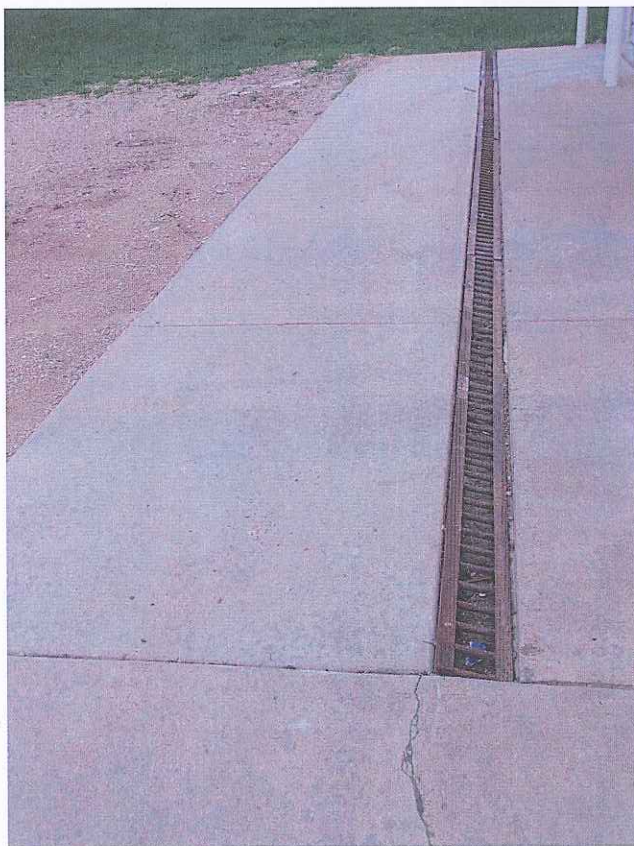
On the southeast corner of the facility, I observed an out building used to store raw materials (Photo P1010305, P101306). I observed a drain in the concrete pad on the north side of the out building. This drain's outlet is located immediately to the east of the pad. There was some track out visible on the north side of the out building (Photo

34: P1010273 Description: Concrete pad on north end of out building.
 Location: Northwest corner of out building. Direction: East Date: 5/13/2014

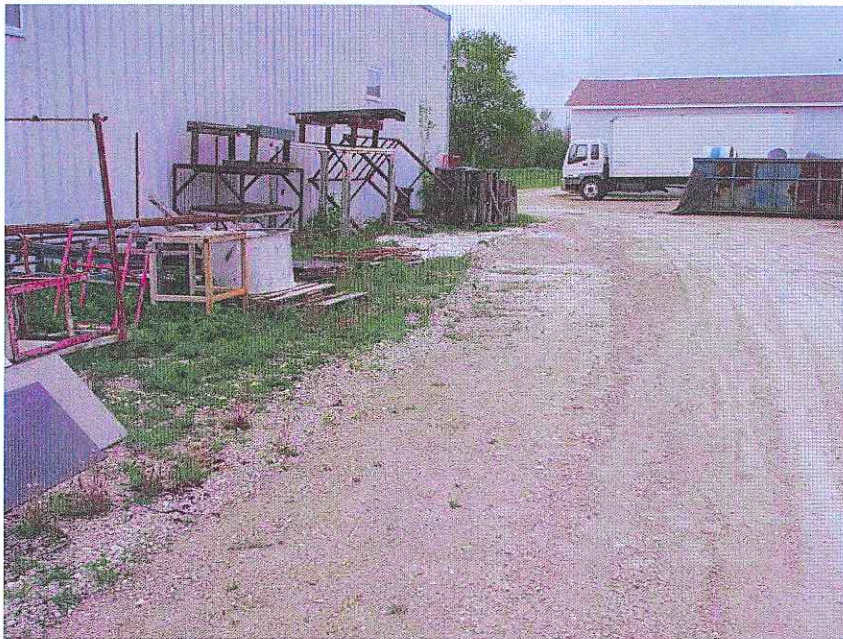
35: P1010274 Description: Outdoor storage area on south side of main plant.
Location: Southwest corner of main plant. Direction: East. Date: 5/13/2014

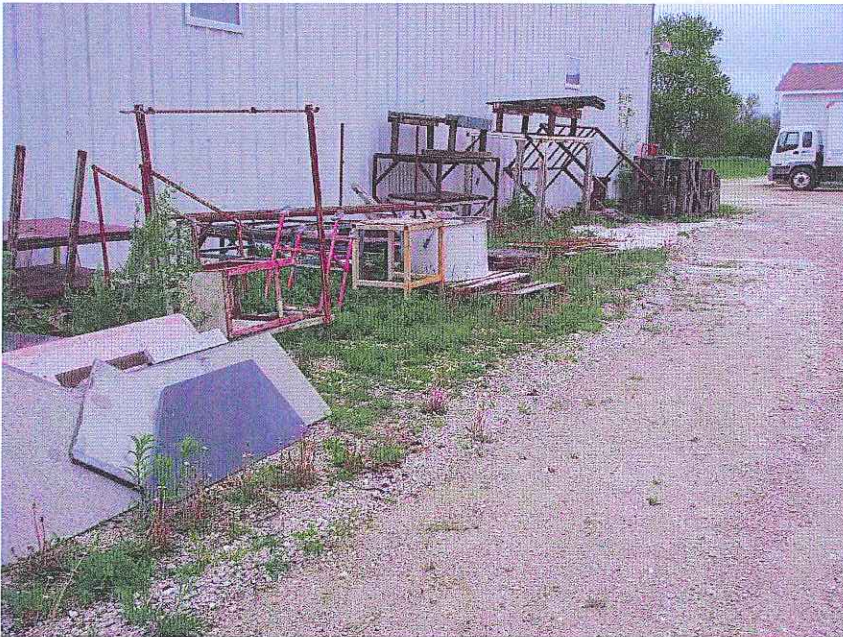
36: P1010275 Description: Outdoor storage area on south side of main plant.
Location: Southwest corner of main plant. Direction: East. Date: 5/13/2014

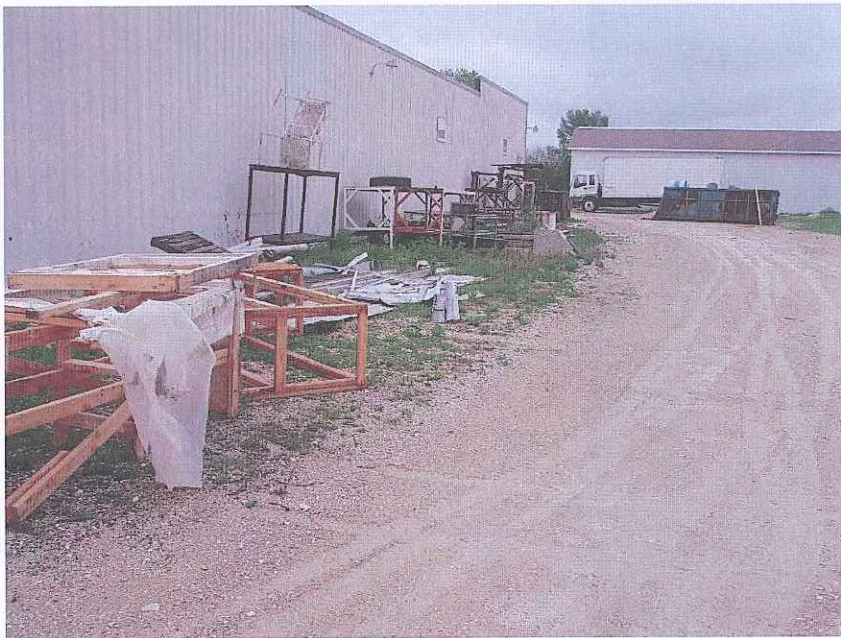
37: P1010276 Description: Outdoor storage area on south side of main plant.
Location: Southwest corner of main plant. Direction: East. Date: 5/13/2014

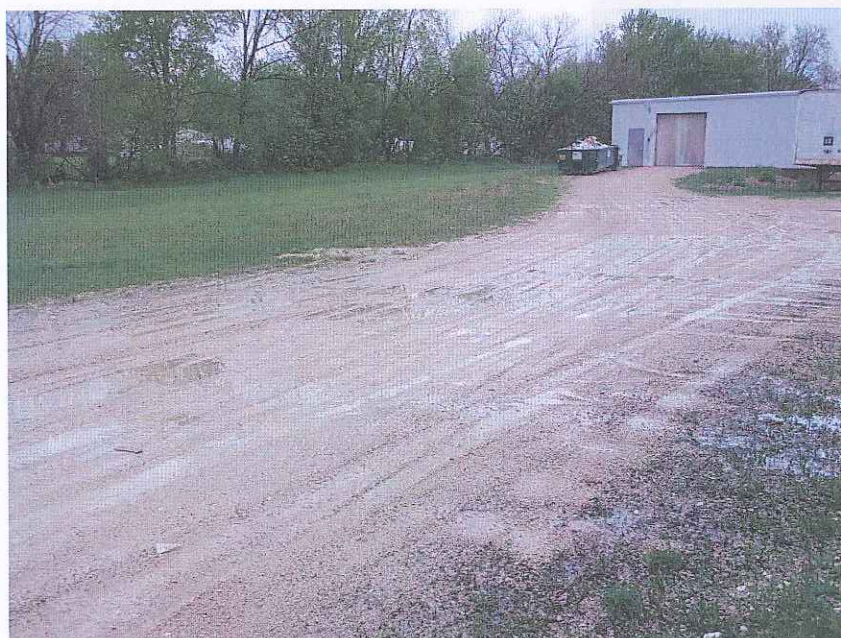
38: P1010277 Description: West side loading dock. Grassed stormwater swale on the left.
Location: Southwest corner of main plant. Direction: Northwest. Date: 5/13/2014

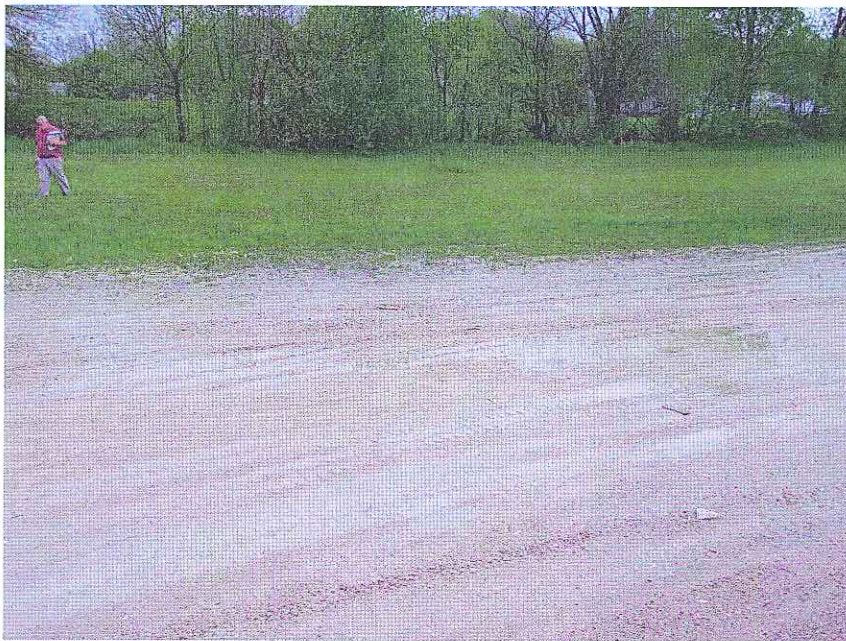
39: P1010278 Description: Grassed storm water swale and storm water drain.
 Location: Southwest side of main plant. Direction: West Date: 5/13/2014

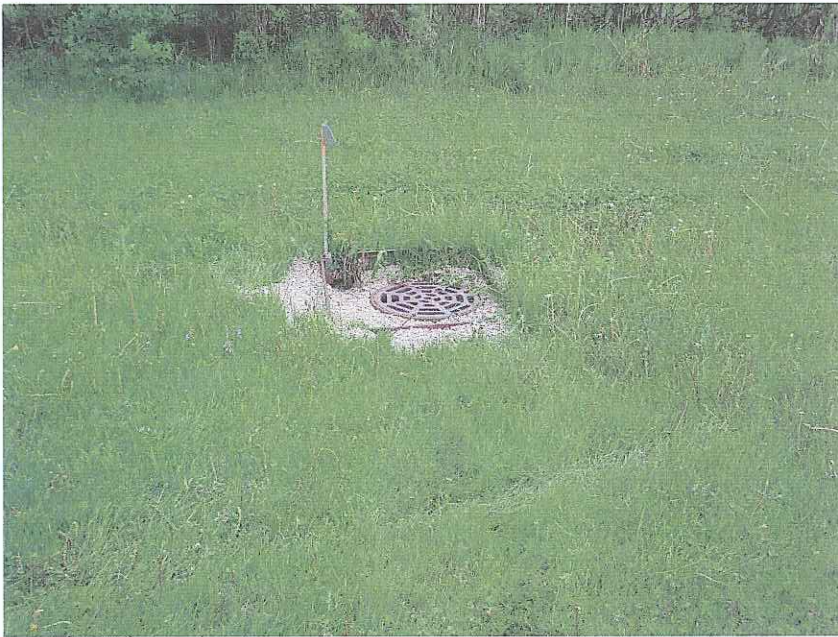
41: P1010280 Description: Storm water drain with gravel surrounding it.
Location: Southwest side of main plant in grassed swale. Direction: West

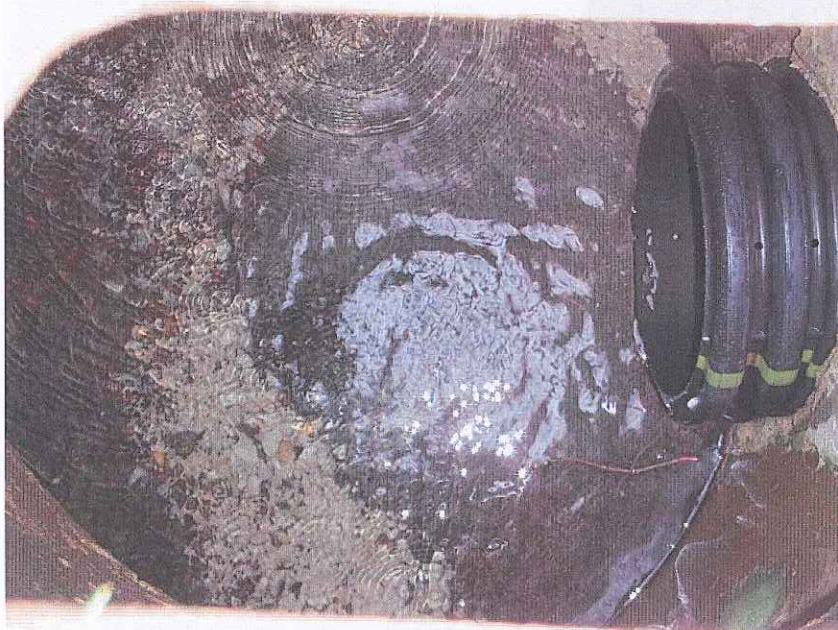
42: P1010281 Description: Interior of storm water drain. Note presence of gravel from around drain in drain pipe. Location: Southwest side of main plant in grassed swale. Direction: Down.

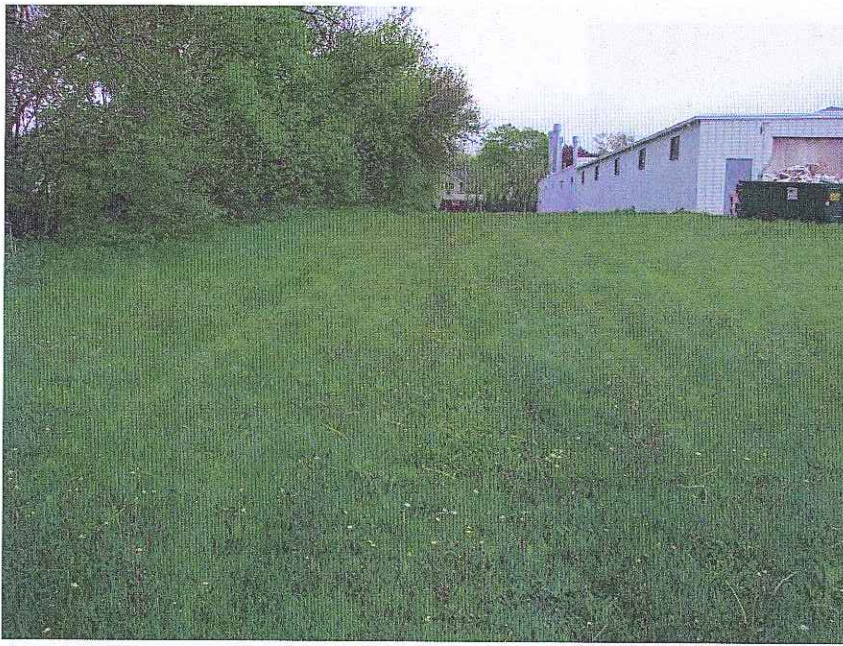
43: P1010282 Description: Grassed storm water swale on west side of main plant.
Location: Southwest of main plant. Direction: North. Date: 5/13/2014

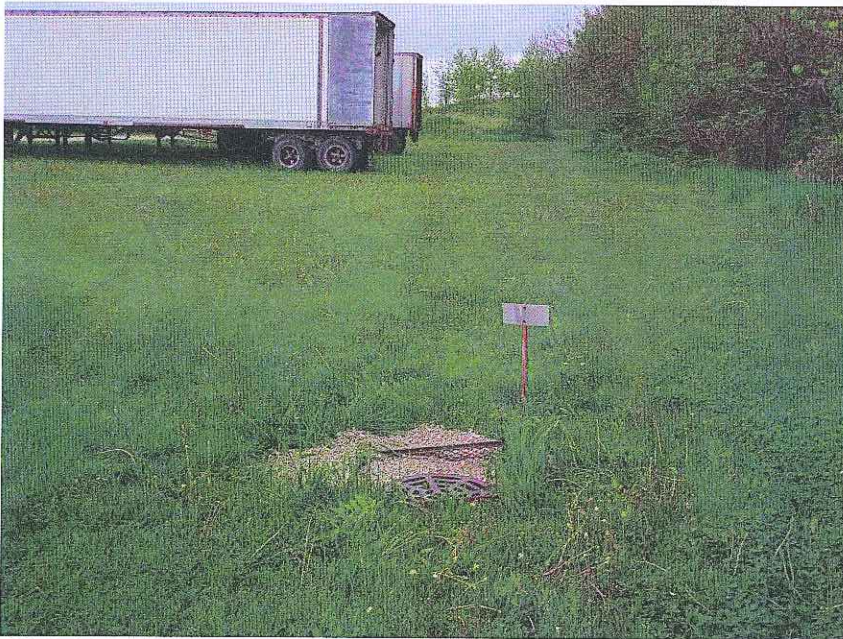
44: P1010283 Description: Grassed storm water swale on west side of main plant.
Location: Southwest of main plant. Direction: South. Date: 5/13/2014
